NATIONAL ADVISORY COMMITTEE FOR AERONAUTICS.

No. 32

CAUSES OF CRACKING OF IGNITION CABLE.

F. B. Silsbee, *J B Dempsey*  
Aeronautic Power Plants Section,

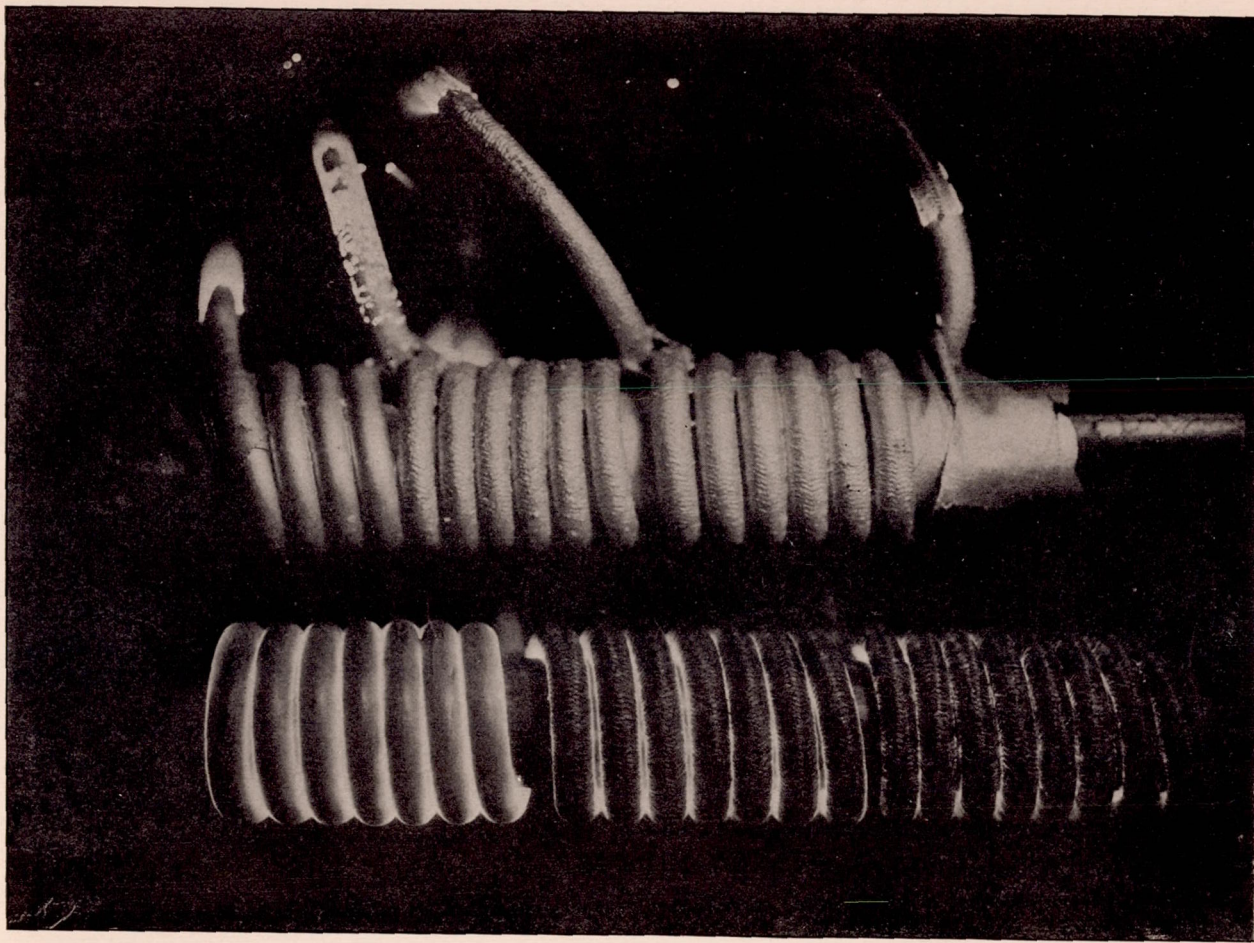
FIG. 2.—Corona on ignition cables on 1-inch arbor. Exposure to corona only 15 minutes at 13 200 volts A. C. and to artificial light 5 seconds to show location of discharge.

Upper mandrel from left to right: Kerite bare, mineral rubber, kerite uncovered.

Lower mandrel from left to right: Kerite bare, kerite covered, mineral rubber.

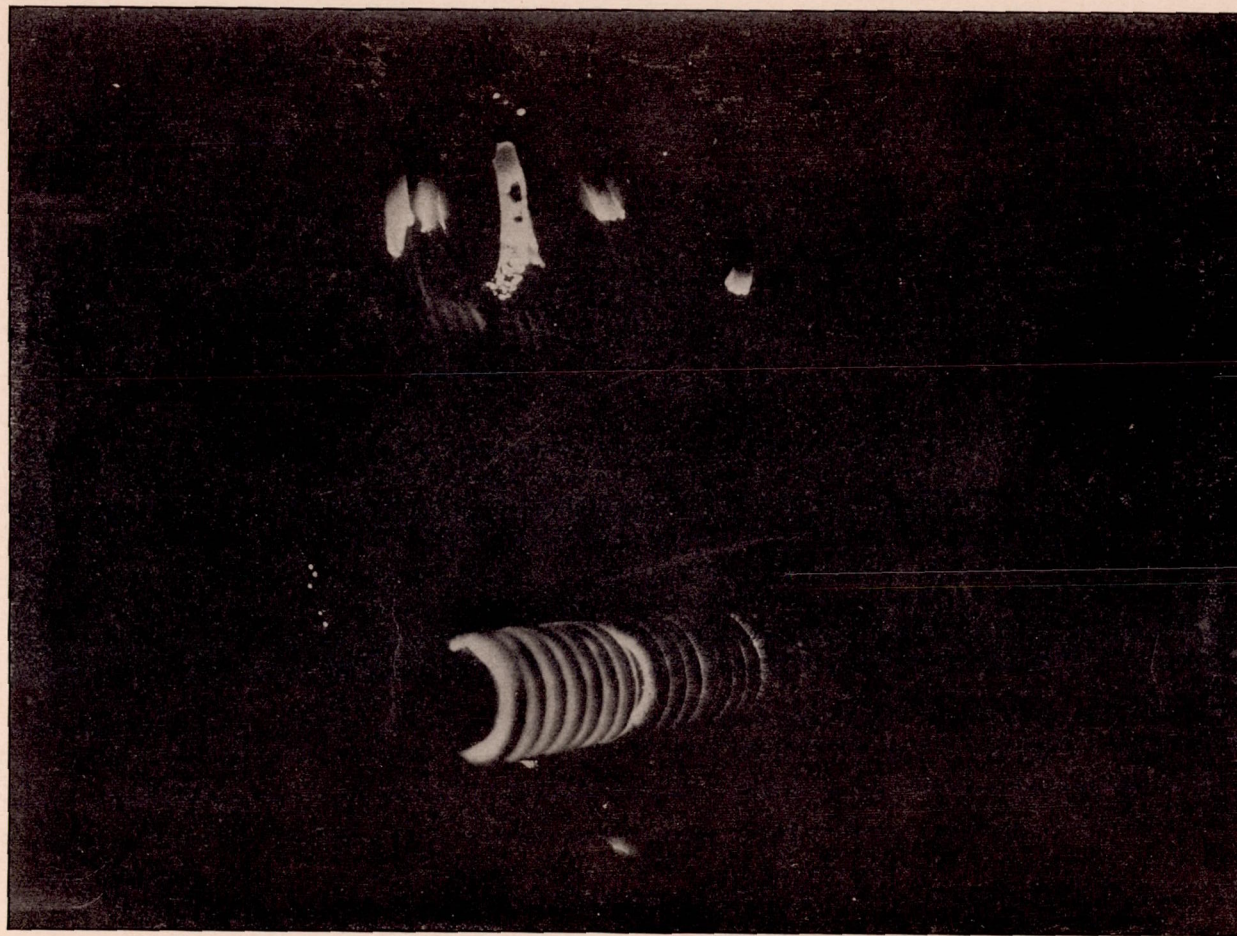
FIG. 1.—Corona on ignition cables on 1-inch arbor. Exposure to corona only 20 minutes at 13 200 volts A. C.  
Upper mandrel from left to right: Kerite bare, mineral rubber, kerite covered. All three specimens covered with conducting paint, except at lower ends where corona appears.  
Lower mandrel from left to right: Kerite bare, kerite covered, mineral rubber. Specimens untreated.

A possible remedy for this trouble would be to cover the cable with a closely adhering coating of conducting material such as conducting paint or water soaked braid. This will prevent the tendency to form corona, as is shown in the photographs. It is, however, objectionable on account of the increase in the electrostatic capacity of the leads which results in a reduction of the maximum voltage produced by the ignition system, and also because most forms of conducting paint are liable to crack and produce at the cracks an excessive amount of corona. The use of an insulator having as small a value as possible for the dielectric constant is advisable as the voltage gradient in the air outside the cable is thereby reduced. There seems to be considerable difference in the rapidity with which different insulations are attacked chemically by the ozone. The ordinary impregnated braids help very materially in preventing cracking, probably because they are nearly air tight and prevent the ozone from reaching the rubber. After much bending, however, they will probably lose their efficacy. Supporting the cables on insulating materials at a distance from grounded conductors is beneficial in reducing the corona and also reducing the electrostatic capacity. It is, however, liable to cause inductive effects between the different cables, which may lead to the production of sparks in the wrong engine cylinder, unless the cables are placed apart from one another,
